# PAVEMENTS AND STUDED TIRE DAMAGE

## WSDOT - State Materials Laboratory

### **UPDATE: December 2008**

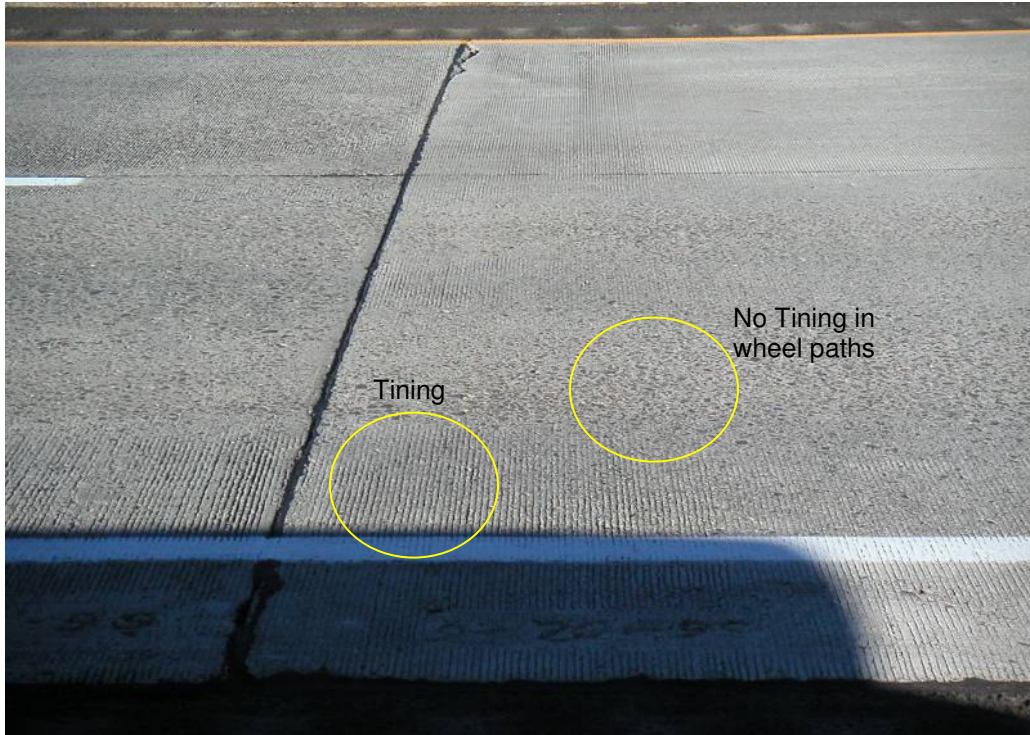
Eight year old concrete pavement, Washington State: Photo 3 shows a concrete pavement constructed in 1995 on state route (SR) 395 in the vicinity of Ritzville, just south of Interstate (I) 90. At the time of this photo, this pavement had been in service for eight years (photo taken in 2003). The current average annual daily traffic on this route is approximately 6,800 vehicles. This pavement had a surface treatment that is referred to as “transverse tining,” Transverse tining is created by pulling a rake across the wet concrete which forms shallow grooves on the surface, similar to the texture of corduroy (Photo 4). These shallow grooves, or tining, increase the pavement skid resistance. Photo 3 shows that the tining has been completely removed from the wheel paths, due to studded tires, while the tining outside of the wheel path is intact at the edges of the pavement.

Photo 3. Concrete pavement on SR-395 south of I-90.  
 ADT: 6,800 vehicles  
 Pavement age: Eight years

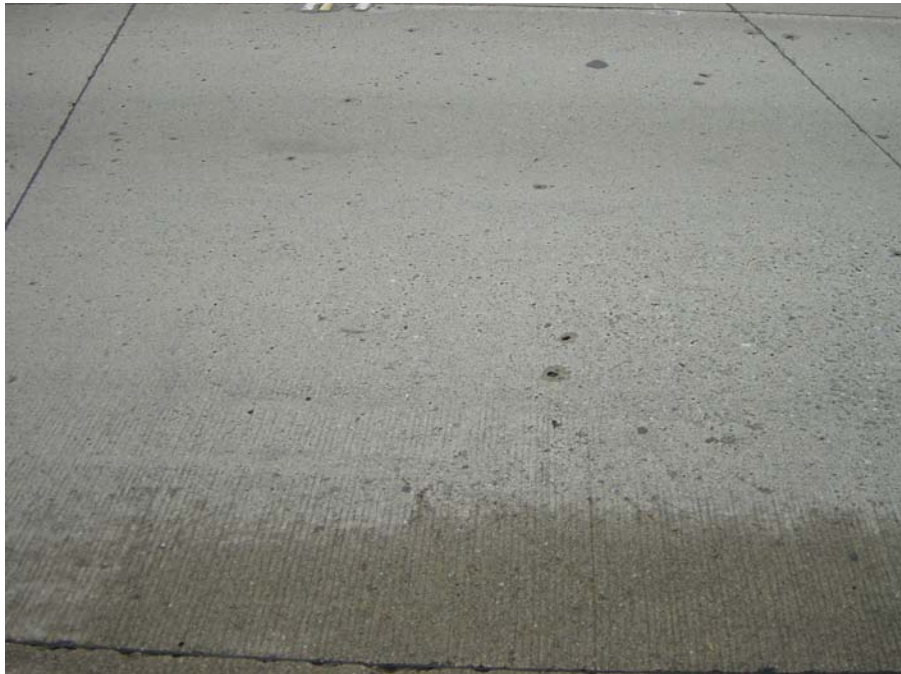
16 year old concrete pavement, Washington: Photo 6 shows a 16 year old concrete pavement constructed in 1989 on I-90 in Seattle in the vicinity of Rainier Avenue (photo taken in 2005). This pavement has an average annual daily traffic of 120,000 vehicles.

Photo 6. Concrete pavement on I-90 in Seattle (Rainier Avenue).  
ADT: 120,000 vehicles  
Pavement Age: 16 years

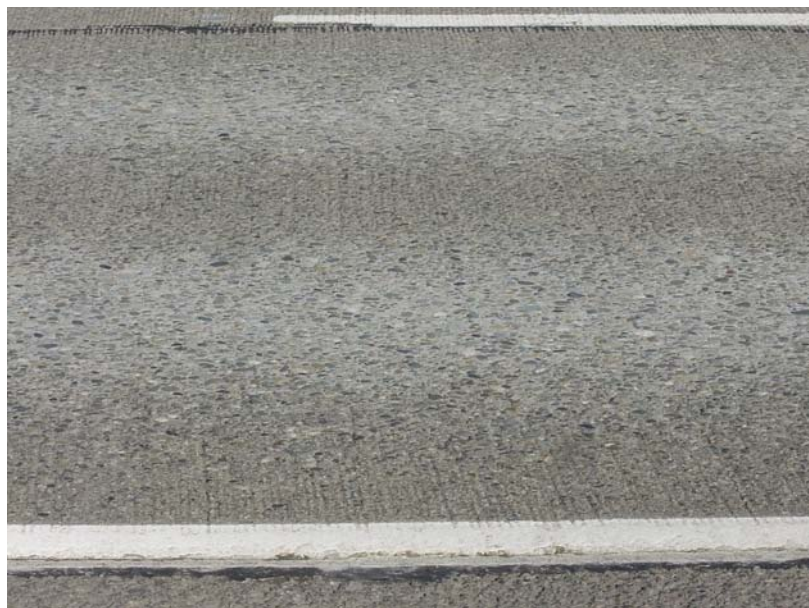
28 year old concrete pavement, Washington: Photo 8 shows a 28 year old concrete pavement constructed in 1977 on I-90 near Preston-Fall City. The average annual daily traffic on this section of pavement is 50,000 vehicles.

Photo 8. Concrete pavement on I-90 near Preston Fall City.  
ADT: 50,000 vehicles  
Pavement Age: 28 years

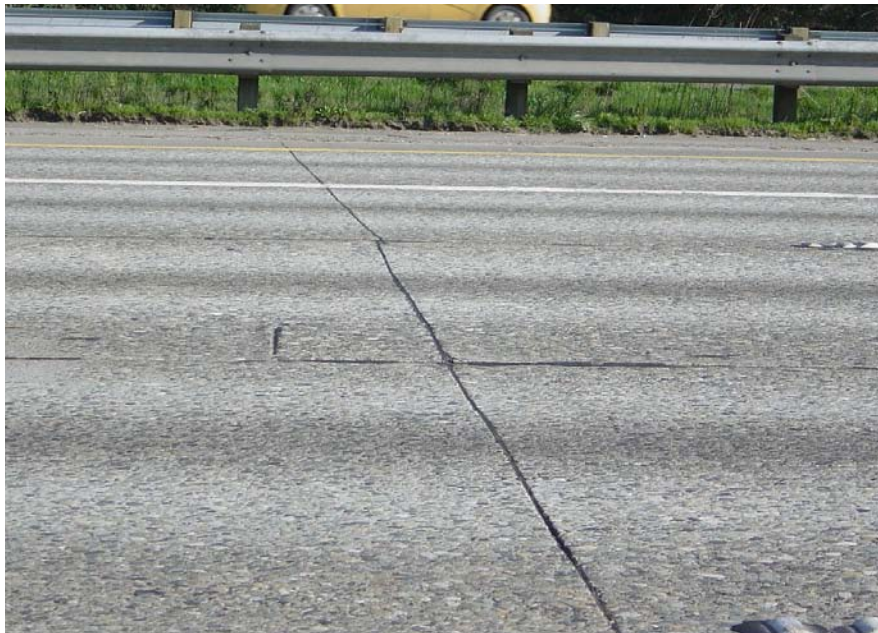
34 year old concrete pavement, Washington: Photo 10 shows a 34 year old concrete pavement constructed in 1967 on I-5 in Seattle in the vicinity of Boeing Field (photo taken 2005). The average annual daily traffic on this section of pavement is 204,000 vehicles.

Photo 10. Concrete pavement on I-5 near Boeing Field.  
ADT: 204,000 vehicles  
Pavement Age: 34 years

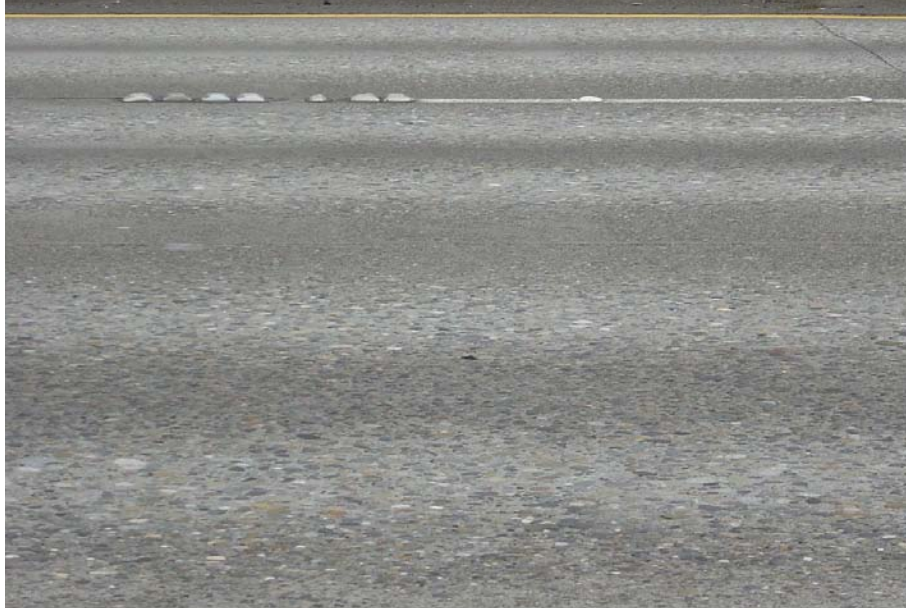
40 old concrete pavement, Washington State: Photo 11 illustrates the concrete pavement surface on I-5, in the vicinity of the Tacoma Dome. WSDOT constructed this pavement 40 years ago, in 1965 (photo taken 2005). This section of I-5 has a current average annual daily traffic of 194,000 vehicles. Studded tires have worn away the top surface of the concrete, exposing the large rock below. The worn areas are lower than the rest of the pavement, forming ruts that tend to pond water, creating safety concerns. Severe ruts must be addressed through pavement rehabilitation. The wear is more prevalent in the wheel paths than at the pavement edges and center of the lane.

Photo 11. Concrete pavement on I-5 near the Tacoma Dome.  
ADT: 194,000 vehicles  
Pavement Age: 40 years

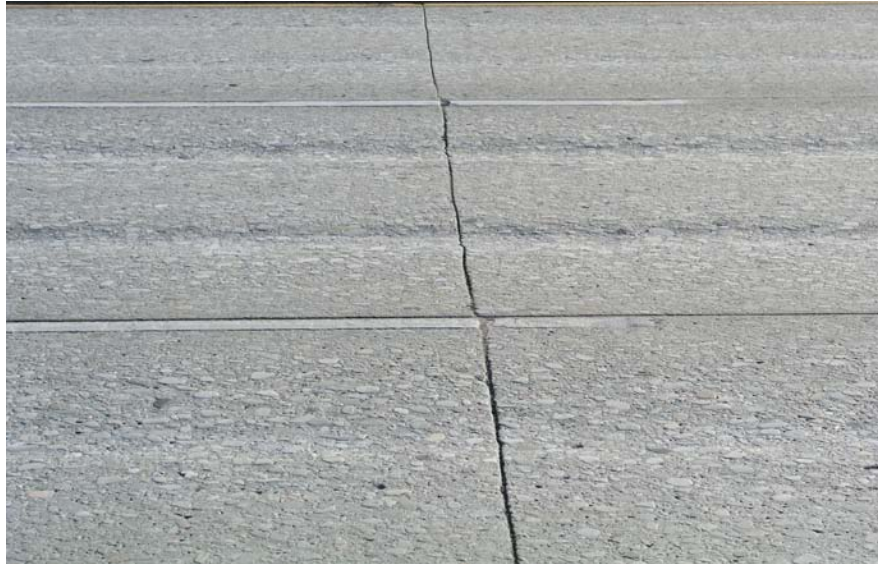
48 year old concrete pavement, Washington State: Photo 12 shows the concrete pavement surface on I-90 in Spokane, vicinity of Altamont Street that was constructed 48 years ago, in 1958. This section of I-90 has an average annual daily traffic of 100,000 vehicles. What is interesting to note on this pavement section is that in 1995 WSDOT conducted a rehabilitation project to diamond grind the existing surface to remove studded tire damage, 11 years later the studded tire wear continues to develop and is visibly noticeable (photo taken 2006). This photo also shows all three lanes on this highway section. The bottom of the photo is the far right lane and the top portion of the photo shows the far left lane. Another characteristic that is typical of studded tire wear is that on multi-lane facilities (3 or more lanes in one direction) the middle lane generally has the most severe studded tire damage (i.e. the location of the majority of the passenger vehicle traffic).

Photo 12. Concrete pavement on I-90 in Spokane.  
 ADT: 100,000 vehicles  
 Pavement Age: 48 years

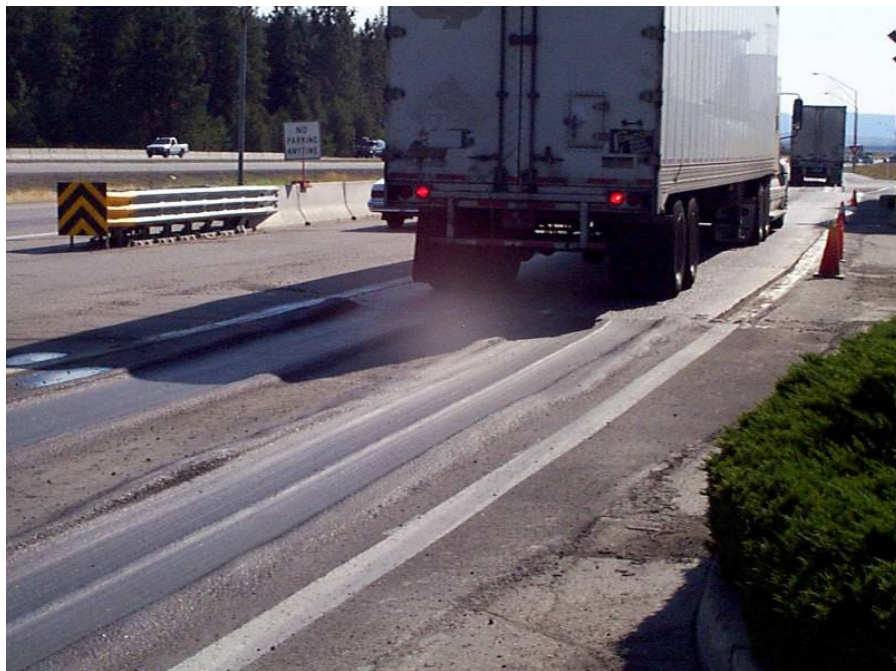
A spectacular, but not typical, hot mix asphalt pavement rutting failure is shown in Photo 13: too much liquid asphalt in this pavement lead to the rapid rutting and shoving seen in the photo. Please note that this is a rare failure on a very small section of a truck weigh scale; the majority of hot mix asphalt pavement rutting is not this severe.

Photo 13. Spectacular, but not typical, hot mix asphalt pavement rutting (I-90 Port of Entry Weigh Scale, Spokane vicinity).

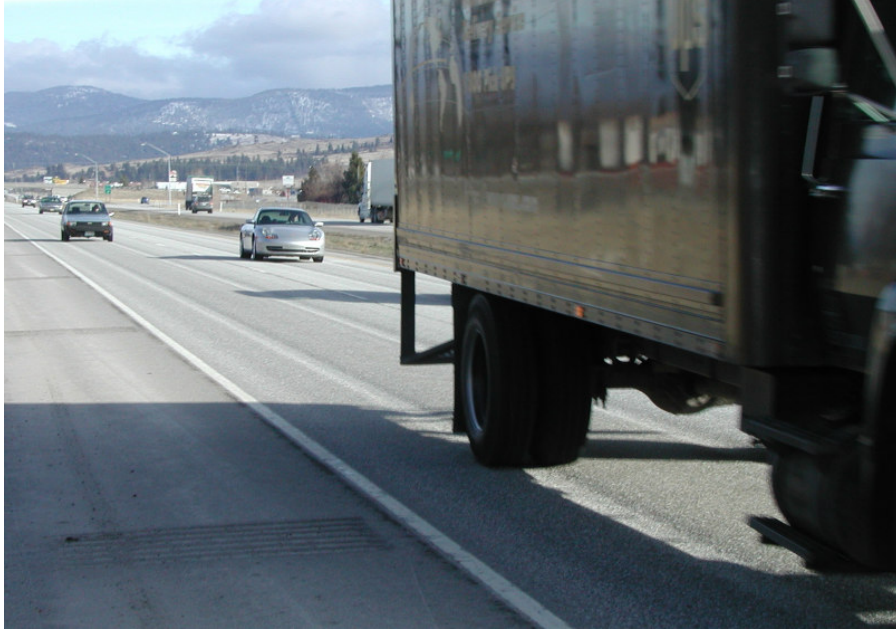
Hot mix asphalt pavement raveling due to studded tires is quite different in appearance (Photo 14). Studs grind the surface of the hot mix asphalt pavement, wearing a groove into the roadway. In Photo 14, note that the dual wheel width of the semi truck exceeds the width of the studded tire groove (or rut), while the car wheels of the vehicle shown in the background lay directly within the wear pattern. The dynamics of studded tire action include three phases; as the studded tire moves over the pavement, there are “spikes” in force at the beginning and at the end of contact. During these spikes, energy is transferred to the pavement in the form of scratching. Between these spikes, the studs have a “punching” action that breaks up aggregate and picks out the pavement surface.

Photo 14. Wear due to studded tires on a hot mix asphalt pavement (I-90 in the vicinity of the Idaho Border).

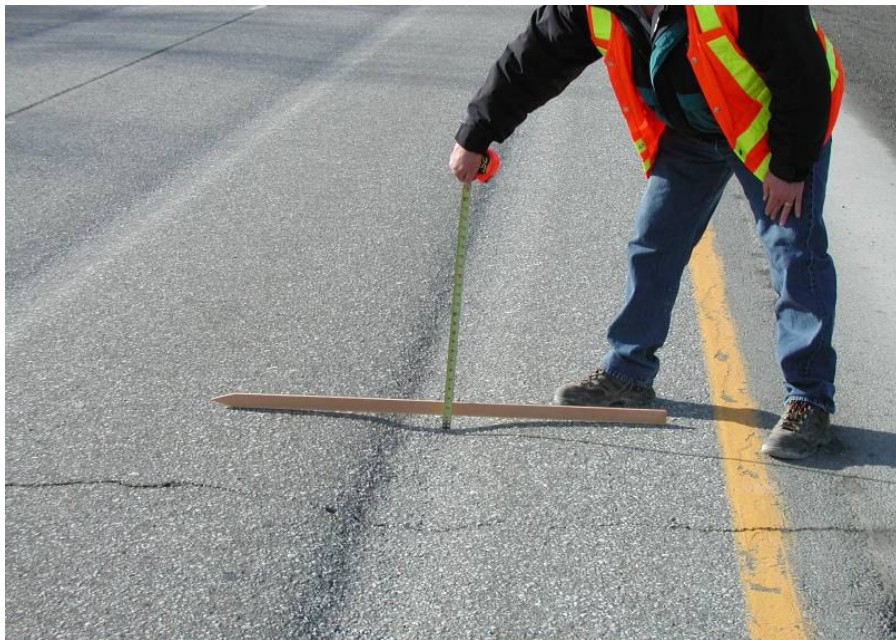
Photo 15 shows a close-up of an open-graded hot mix asphalt pavement that has been damaged by studded tires. This pavement was originally placed in 1992 and was replaced three years later due to the significant rut caused by studded tires (approximately 1-½ inches deep).

Photo 15. Studded tires raveling on hot mix asphalt pavement on I-90 vicinity of Idaho border.

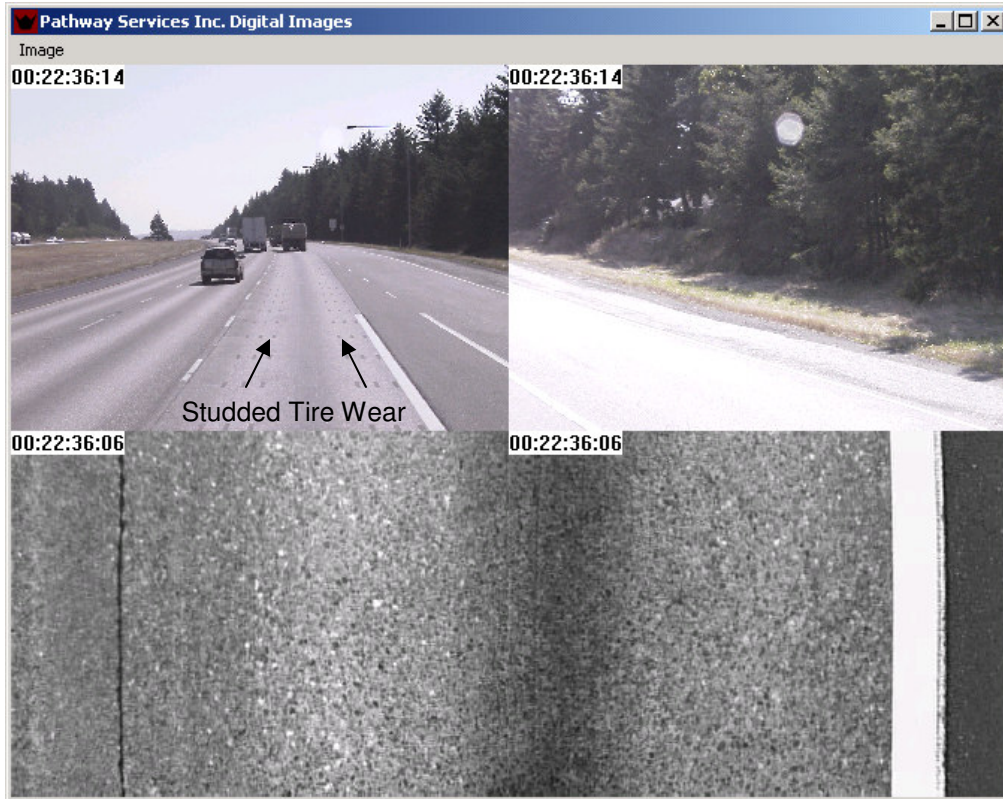
Photo 18. Pavement view in location of studded tire wear (I-5, northbound, milepost 112.23, Lacey vicinity, concrete pavement).

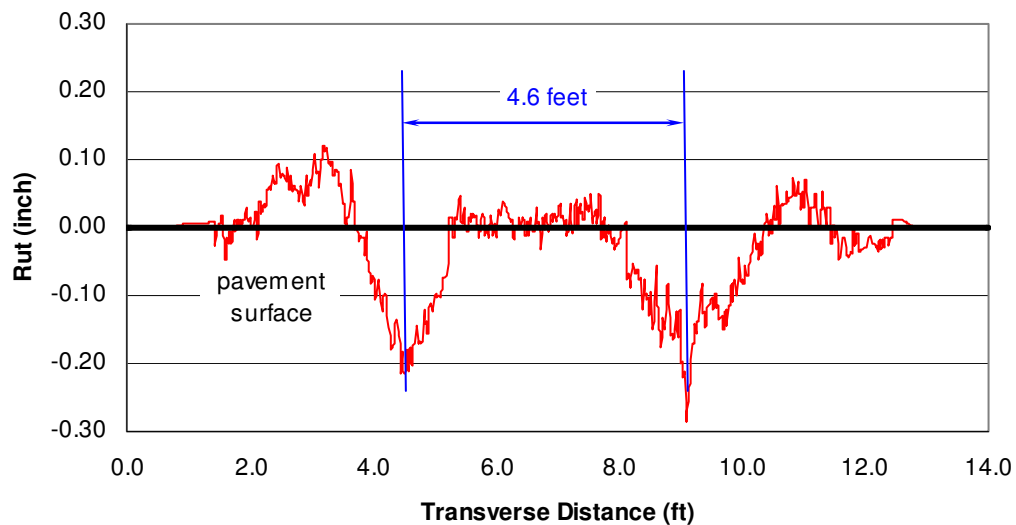
Figure 2. Transverse profile in an area of studded tire wear (I-5, northbound, milepost 112.23, Lacey vicinity, concrete pavement).

The profiles above are exaggerated on the vertical scale, compared to the horizontal scale, but they provide a clear picture of the amount of wear or rutting. The example on concrete pavement wear is

entirely due to studded tires and shows a loss of material from the pavement. The example on hot mix asphalt pavement ruts are from shoving (or plastic flow) where the pavement has been physically deformed by heavy truck traffic.

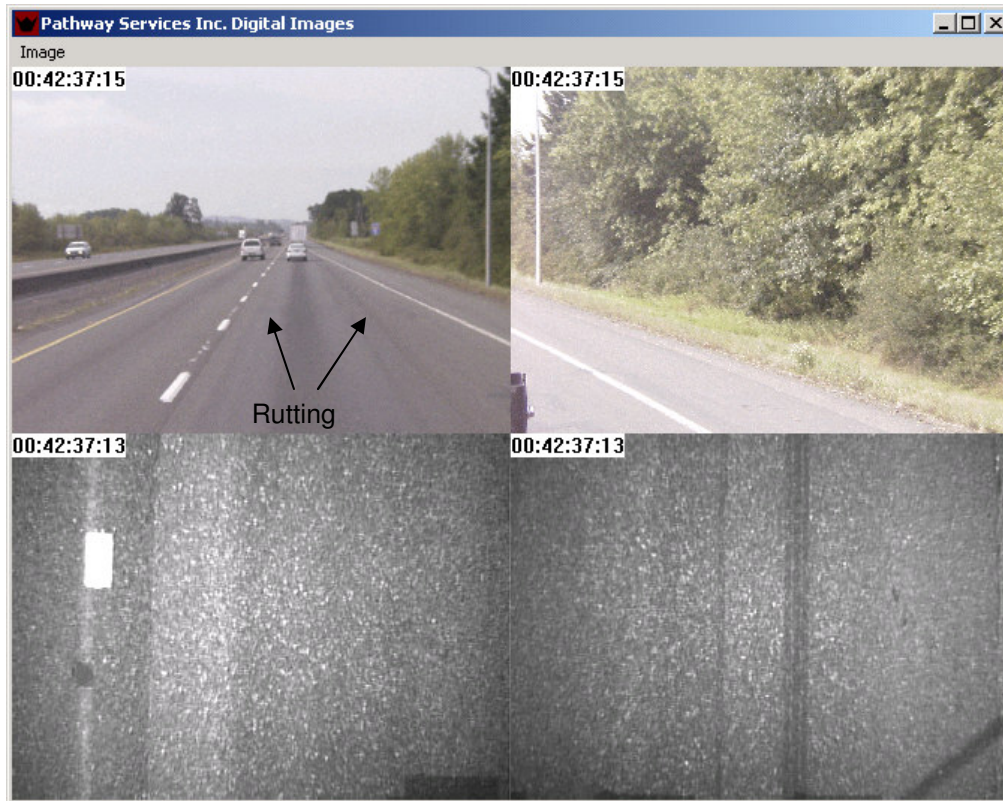
Photo 19. Pavement view in location of rutting (I-5, southbound, milepost 63.00, Toledo vicinity, hot mix asphalt pavement).

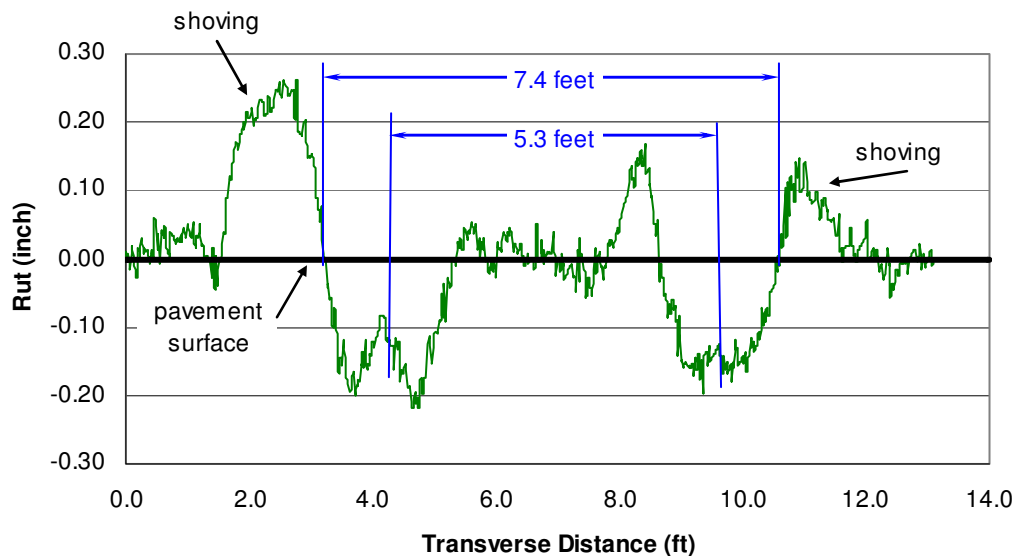
Figure 3. Transverse profile in location of rutting (I-5, southbound, milepost 63.00, Toledo vicinity, hot mix asphalt pavement).
