**PRE-DEMOLITION ASBESTOS SURVEY  
FOR THE  
VACANT WAREHOUSE BUILDING  
LOCATED AT  
411 WEST CATALDO AVENUE  
SPOKANE, WA**

**Project Number: S10-025.2**

**City of Spokane – Riverfront Park  
Parks & Recreation Department**

March 23, 2010

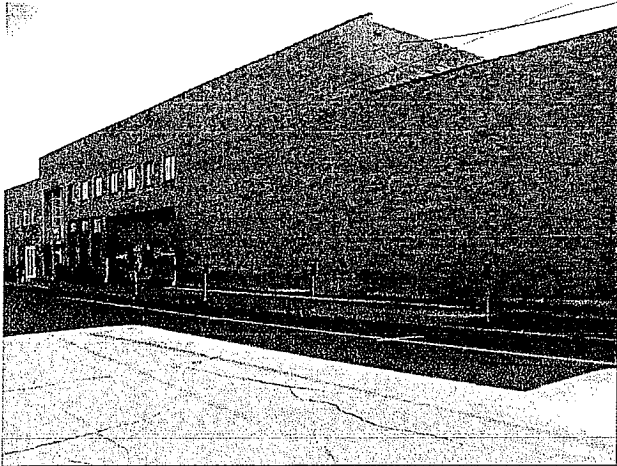
- ◆ **White Window Glazing** located on the exterior metal window units present from on the north exterior wall of the 2<sup>nd</sup> floor was found to contain asbestos. This class II, non-friable, miscellaneous material contains 1-2% chrysotile asbestos. There is approximately 170 lf of this material present with 7 exterior window units.

FRONT NORTH VIEW OF THE BUILDING; 411 W. CATALDO AVE; 2<sup>ND</sup> FLOOR WINDOWS ARE GLAZED WITH ACM PUTTY

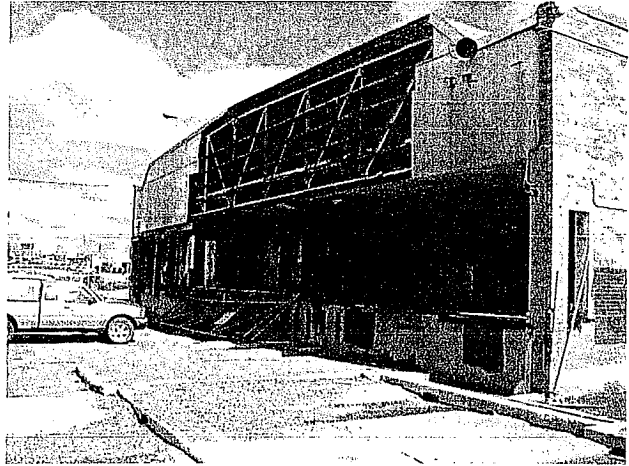
- ◆ **Gray Cement Board Paneling** located on the walls (3 rooms) & ceiling (1 room) of the second floor west half area, minor quantities stored in the east attic space (NW ceiling area), on the soffit of the west loading dock area, and contaminating parking lot gravel adjacent to the west loading dock was found to contain asbestos. This class II, non-friable, miscellaneous material contains 20-25% chrysotile asbestos and 1-2% crocidolite asbestos. There is approximately 1,820 ft<sup>2</sup> of this material associated with the 2<sup>nd</sup> floor & attic area, approximately 700 ft<sup>2</sup> of this material associated with the loading dock soffit, and approximately 1,000 ft<sup>2</sup> of gravel parking lot & loading dock floor area contaminated with small to moderate sized pieces of this material.

WEST EXTERIOR SIDE OF BUILDING; ALSO SHOWING ACM CAB WITH LOADING DOCK SOFFITS & CONTAMINATING PARKING AREA

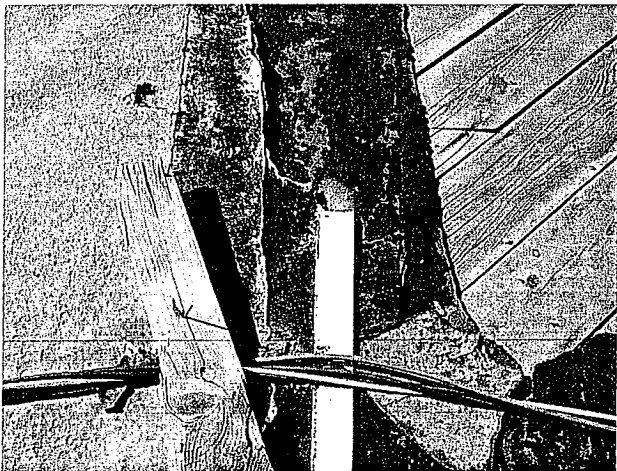
- ◆ **Built-up Layered Roofing** located on exterior roof decks of the building was found to contain asbestos. This class II, non-friable, miscellaneous material contains 35-40% chrysotile asbestos in the exposed roofing tar and felts layers and 5-7% chrysotile asbestos in the bottom most tar layer. There is approximately 14,600 ft<sup>2</sup> of this material present.

CLOSE UP VIEW OF ACM ROOFING SHOWING THICKNESS OF LESS THAN 1/2 INCH

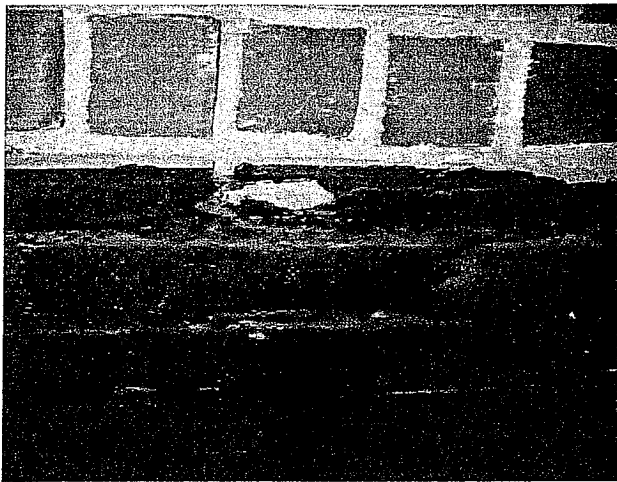
- ◆ **Black Wall Coating** located from on the interior brick walls of the west side 2<sup>nd</sup> floor area was found to contain asbestos. This material is located from the floor up the walls to approximately the four foot level. This class II, non-friable, miscellaneous material contains 6-8% chrysotile asbestos. There is approximately 600 ft<sup>2</sup> of this material present.

VIEW OF ACM-BLACK WALL COATING  
PRESENT THROUGHOUT WEST HALF 2<sup>ND</sup>  
FLOOR AREA

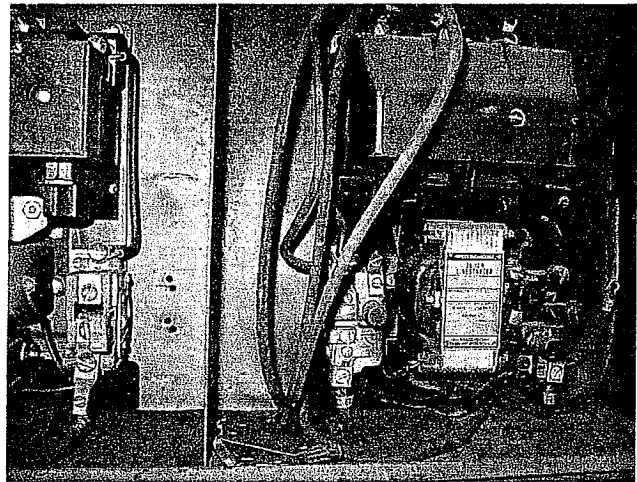
- ◆ **Grey Woven Insulation on Electrical Wiring** located partially exposed in the 2<sup>nd</sup> floor electrical room and within electrical wall panels and routing conduit throughout the building was found to contain asbestos. This class I, friable, TSI material contains 20-25% chrysotile asbestos. The total quantity of this material is unknown but anticipated to be throughout. It should be noted that the associated black and green woven electrical wiring insulations were proven to be free of asbestos.

VIEW OF ACM-GREY WOVEN ELECTRICAL  
WIRING INSULATION IN 2<sup>ND</sup> FLOOR  
ELECTRICAL ROOM

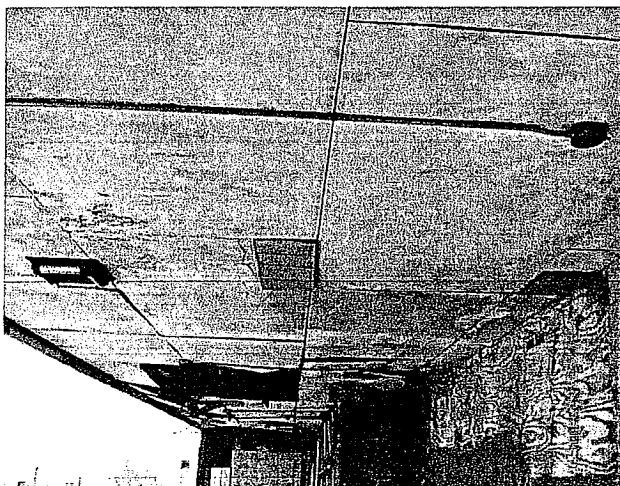
VIEW OF ACM-VFT-CAB AT WEST LOADING  
DOCK SOFFITING

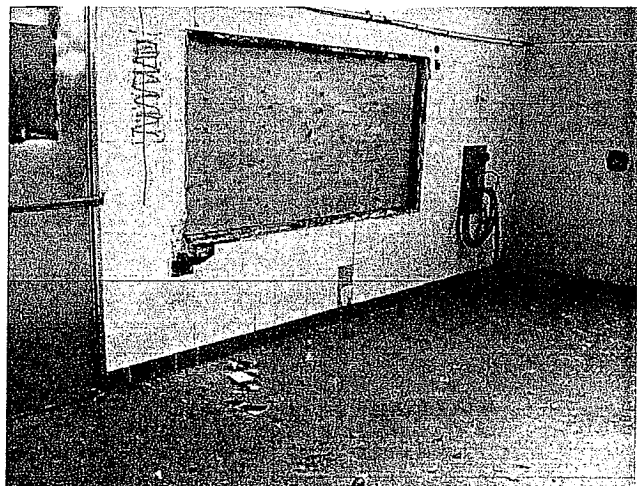
- ◆ **Black Tar Adhesive** located under yellow ceramic wall tile used to infill an older wall opening at the southeast corner of the building was found to contain asbestos. It should be noted that this material is under the covered window present at the south end of the east wall of the main high ceiling room. This class II, non-friable, miscellaneous material contains 7-10% chrysotile asbestos. There is approximately 22 ft<sup>2</sup> of this material present.

VIEW OF MAIN ROOM ACM-BLACK MASTIC  
ASSOCIATED WITH YELLOW CERAMIC WALL  
TILE, ONLY WITH THIS AREA
