**PRE-DEMOLITION ASBESTOS SURVEY
FOR THE
VACANT WAREHOUSE BUILDING
LOCATED AT
444 WEST CATALDO AVENUE
SPOKANE, WA**

Project Number: S10-025.2 A

**City of Spokane – Riverfront Park
Parks & Recreation Department**

March 24, 2010

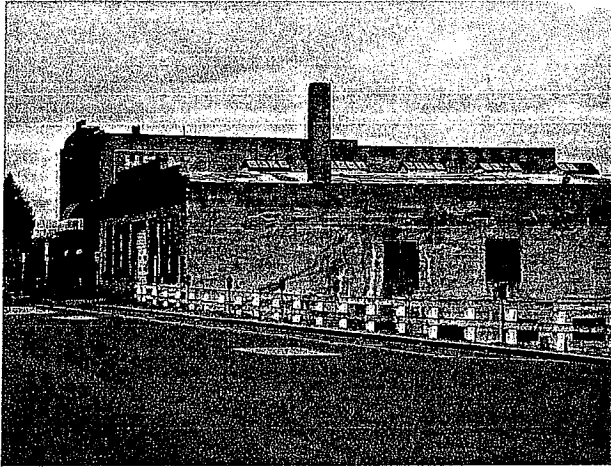
- ◆ **Built-up Layered Roofing** located on exterior roof decks and parapet walls of the building was found to contain asbestos. This class II, non-friable, miscellaneous material contains 4-7% chrysotile asbestos in the built-up systems top and bottom tar layers. There is approximately 15,400 square feet (ft²) of this material present.

FRONT NORTH & WEST SIDES OF THE BUILDING; 444 W. CATALDO AVE; EXTERIOR ROOFING IS ACM

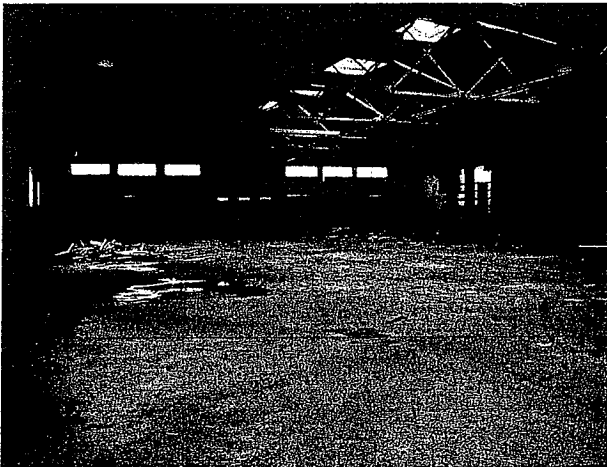
- ◆ **Black Tarpaper** located throughout the building debris piles present in the main open room of the entry level was found to contain <1% chrysotile asbestos. The total quantity of this material is unknown, but present throughout 3 building debris piles. *This material is not regulated for disposal however certain worker health and safety requirements still apply for removal or left in-place demolition operations.*

VIEW OF ENTRY LEVEL MAIN NORTH ROOM SHOWING DEBRIS PILES WITH <1% ACM TARPAPER PRESENT

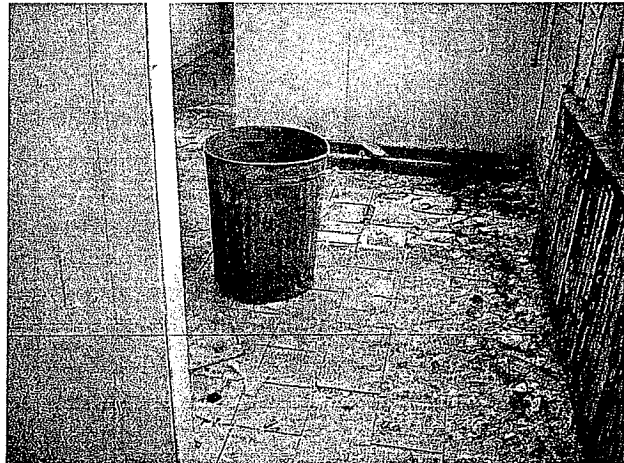
- ◆ **Grey 9”x 9” Vinyl Floor Tile** located in the entry level southwest office area present over the basement vehicle access ramp was found to contain asbestos. This class II, non-friable, miscellaneous material contains 2-3% chrysotile asbestos. There is approximately 360 ft² of this material present. The associated black flooring mastic was proven asbestos-free.

VIEW OF ACM 9" X 9" VINYL FLOOR TILE IN OFFICES AREA OVER BASEMENT VEHICLE ACCESS RAMP

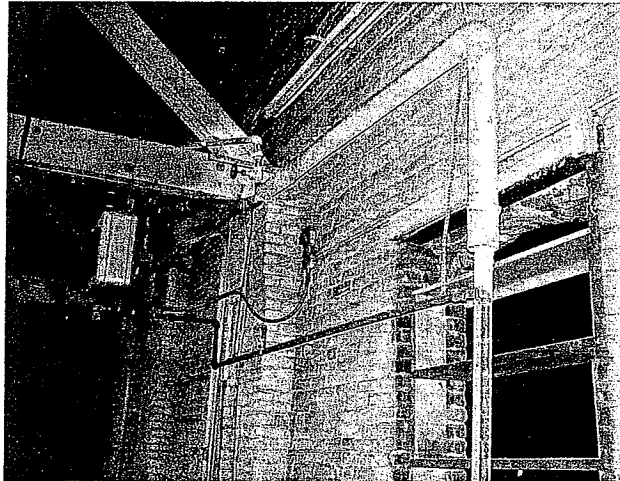
- ◆ **TSI Piping Insulation** located on piping mainly throughout the southern half and northeast corner of the basement and west wall of the SE maintenance room of the entry level was found to contain asbestos. This class I, friable, thermal systems insulation (TSI) material contains 10-15% chrysotile asbestos and 30-35% amosite asbestos. There is approximately 350 linear feet (lf) of this material present.

VIEW OF ACM-TSI PIPING INSULATION ON
WEST WALL OF SE ENTRY LEVEL
MAINTENANCE ROOM

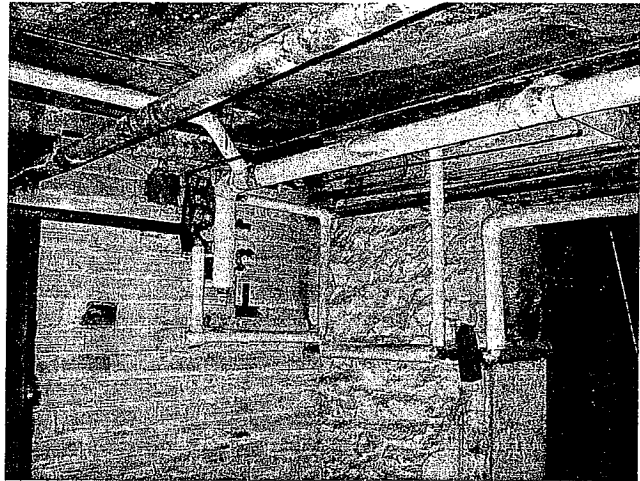
VIEW OF TYPICAL ACM-TSI PIPING
INSULATION PRESENT IN BASEMENT LEVEL

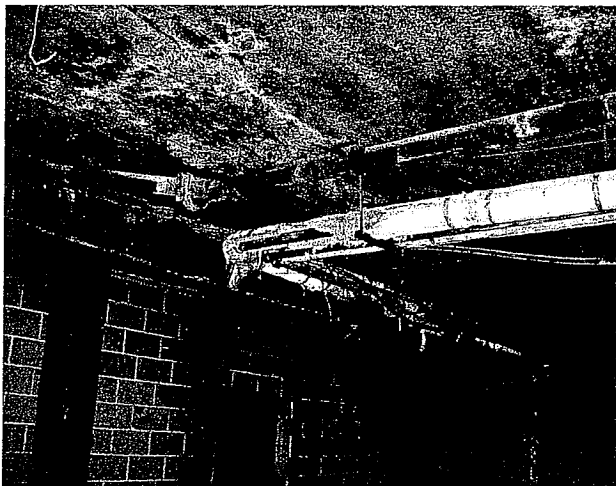
Mountain Consulting identified two (2) class I, friable, TSI asbestos containing materials: Piping Insulation & Mudded Fittings Insulation (located on piping throughout the southern half and northeast corner of the basement level and a minor quantity present on the west center wall area of the southeast maintenance room of the entry level). These TSI materials were in poor deteriorated to good conditions with some material water damaged, delaminating and contaminating basement floor areas; and the majority in serviceable condition with minor areas impacted, abraded or missing.

VIEW OF DETERIORATED ACM-TSI PIPING
INSULATION IN SOUTH HALF OF BASEMENT
