National Transportation Safety Board Aviation Accident Final Report

Location:	Coeur d'Alene, Idaho	Accident Number:	WPR20FA206
Date & Time:	July 5, 2020, 14:22 Local	Registration:	N6373U (A1); N2106K (A2)
Aircraft:	Cessna TU206 (A1); De Havilland DHC-2 (A2)	Aircraft Damage:	Destroyed (A1); Destroyed (A2)
Defining Event:	Midair collision	Injuries:	2 Fatal (A1); 6 Fatal (A2)
Flight Conducted Under:	Part 91: General aviation - Personal (A1); Part 91: General aviation - Aerial observation (A2)

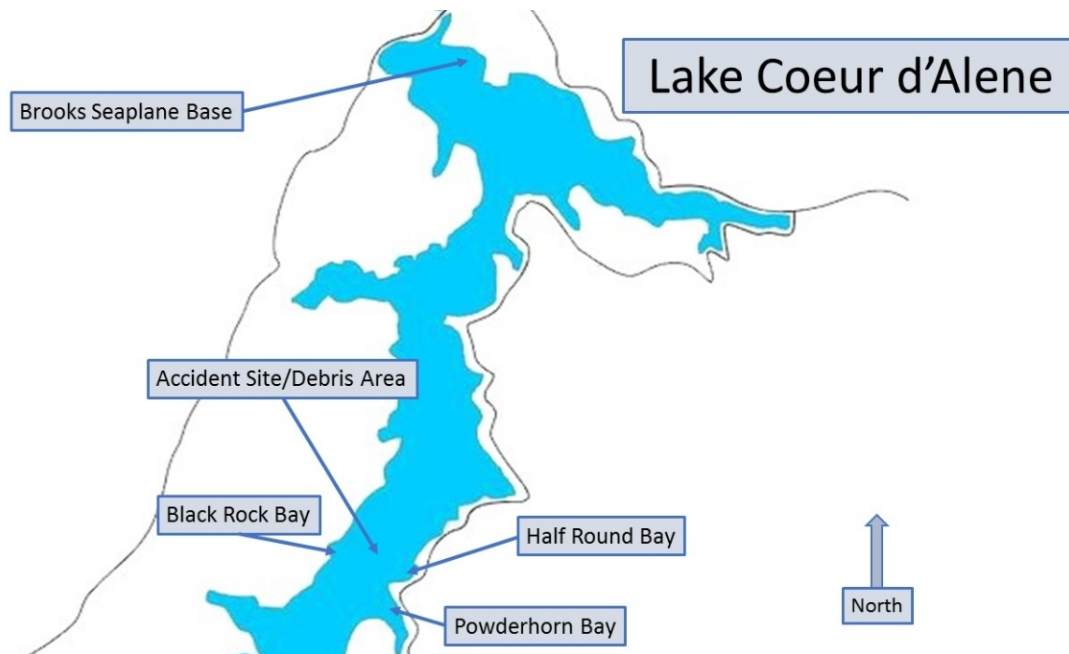
Figure 2. Accident site location.

The wreckage of both airplanes was submerged in about 130 ft of water near the center of the lake between Half Round Bay and Black Rock Bay, as indicated in figure 2. The underwater debris path was about 900 ft in length.
