# PAVEMENTS AND STUDED TIRE DAMAGE

## WSDOT - State Materials Laboratory

### **UPDATE: December 2008**

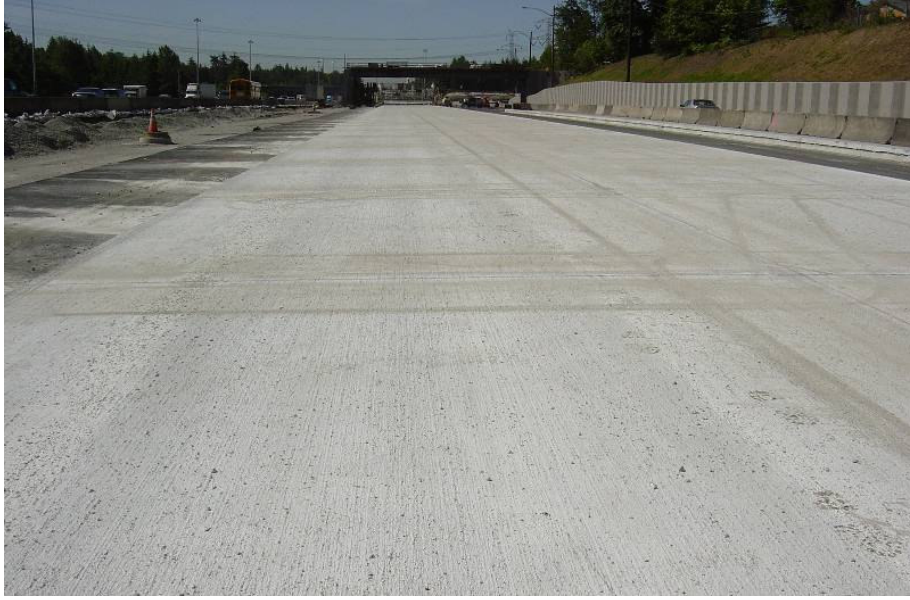
New, Undamaged Concrete Pavement: Photo 1 shows a newly constructed concrete pavement on southbound I-5 in the vicinity of 317<sup>th</sup> in Federal Way. Construction occurred in the summer of 2005 and at the time of the photo, this pavement had received no vehicle traffic. The surface treatment on this concrete pavement was produced by dragging Astroturf (Photo 2) over the unhardened concrete surface, providing a skid resistant surface, as well as a quieter pavement texture. This section will be studied more closely over the next several years to determine long-term durability, skid resistance and noise reduction qualities.

Photo 1. New concrete pavement on southbound I-5 in the vicinity of 317<sup>th</sup> Constructed 2005, not yet under traffic.

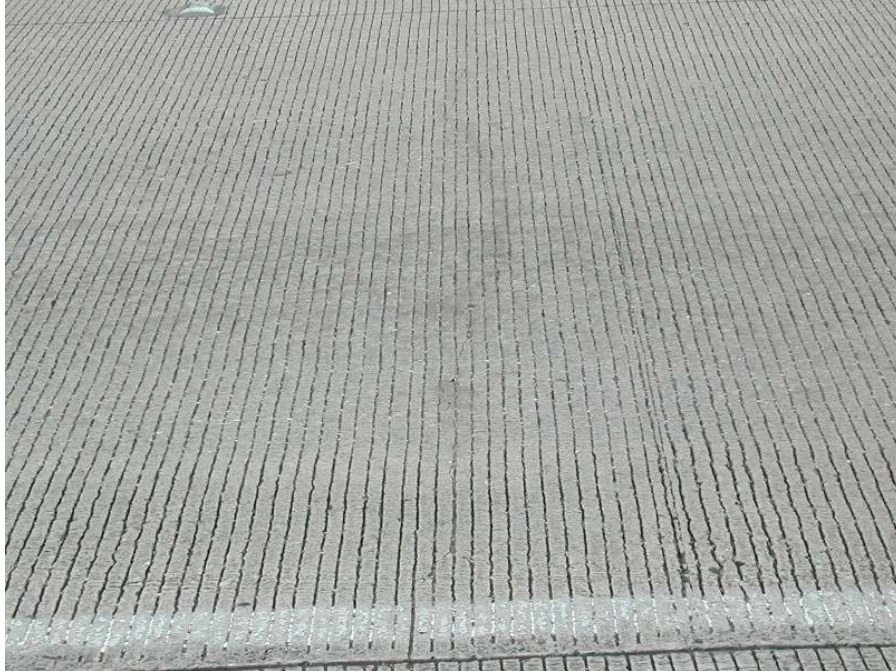
16 year old concrete pavement, Texas: Photo 5 shows a 17 year old concrete pavement constructed in 1989 on I-45 in Houston, Texas (photo taken in 2005). Although the state of Texas allows studded tires, their mild climate results in almost zero studded tire usage, and consequently, no studded tire damage. This roadway carries approximately 178,000 vehicles per day, yet after 16 years the original tining marks are clearly present and unworn. Contrast Photo 5 with Photo 6, which is a similarly aged concrete pavement in the Seattle area with less traffic. The Texas highway has one and a half times the traffic volume of I-90, yet the Washington State pavement clearly shows wear while the Texas highway is in like new condition.

Photo 5. Concrete pavement on I-45 in Houston, TX.  
ADT: 178,000 vehicles  
Pavement Age: 16 years

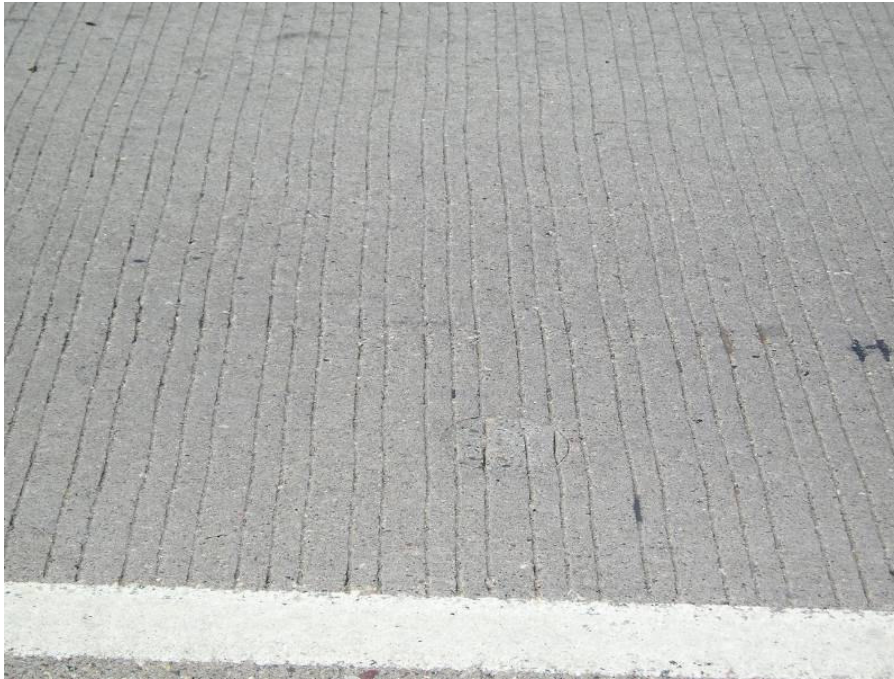
In the 1970's the state of Minnesota was able to successfully ban the use of studded tires. Photo 7 (taken in 2005) shows the surface of a concrete pavement on I-94 in Minneapolis. This pavement was constructed in 1977 and currently carries an average annual daily traffic of 130,000 vehicles.

Photo 7. Concrete pavement on I-94 in Minneapolis, MN.  
ADT: 130,000 vehicles  
Pavement Age: 28 years

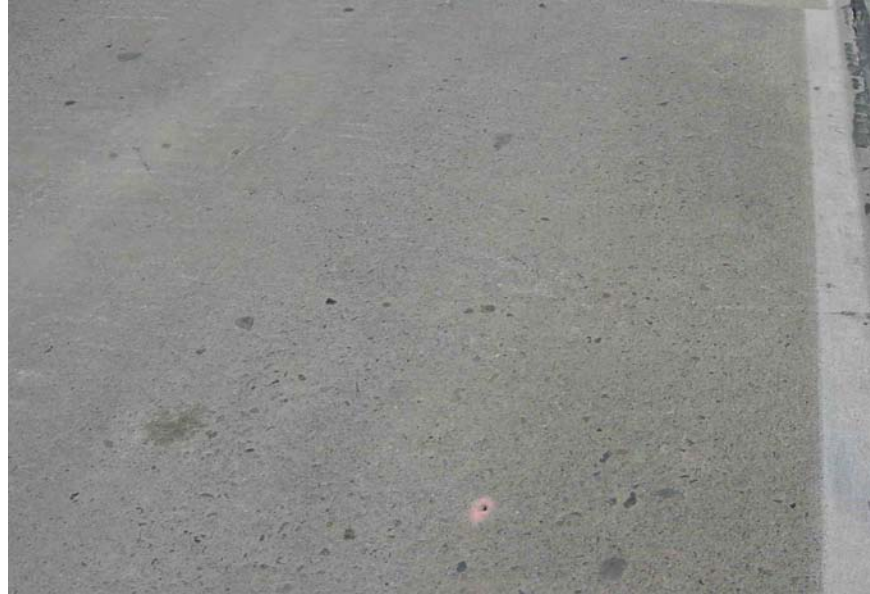
34 year old concrete pavement, California: Photo 9 shows a concrete pavement on SR-101 in Ukiah, California. This pavement was constructed in 1967 (photo taken in 2001). Like Texas, California allows studded tires; however, the mild California climate also results in negligible studded tire usage. Contrast this photo with the damage seen in Photo 10. The current average annual daily traffic on SR-101 in Ukiah is approximately 26,000 vehicles.

Photo 9. Concrete pavement on State Route 101 in Ukiah, CA.  
ADT: 26,000 vehicles  
Pavement Age: 34 years
